SPECIAL REPORT

Moisture in the Roofs of Cold Storage Buildings

Wayne Tobiasson and Alan Greatorex

November 1998

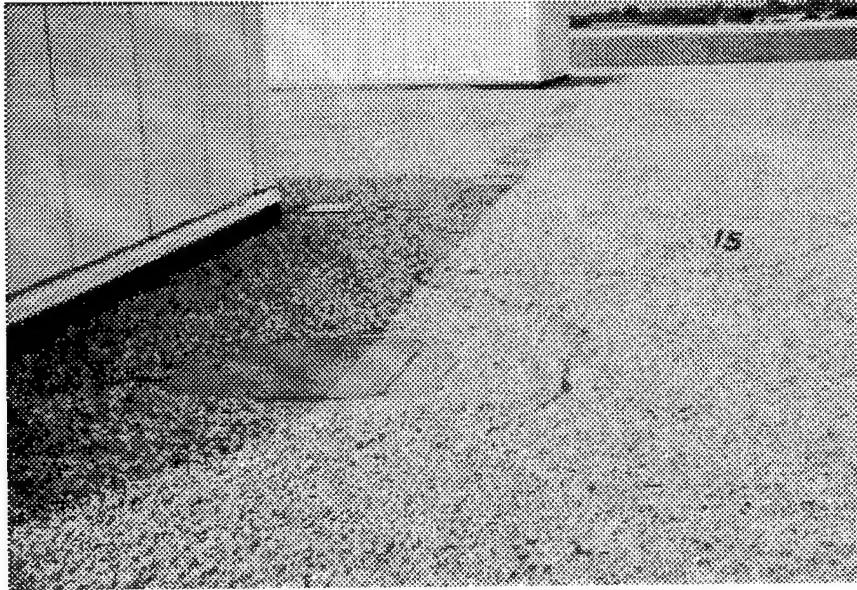
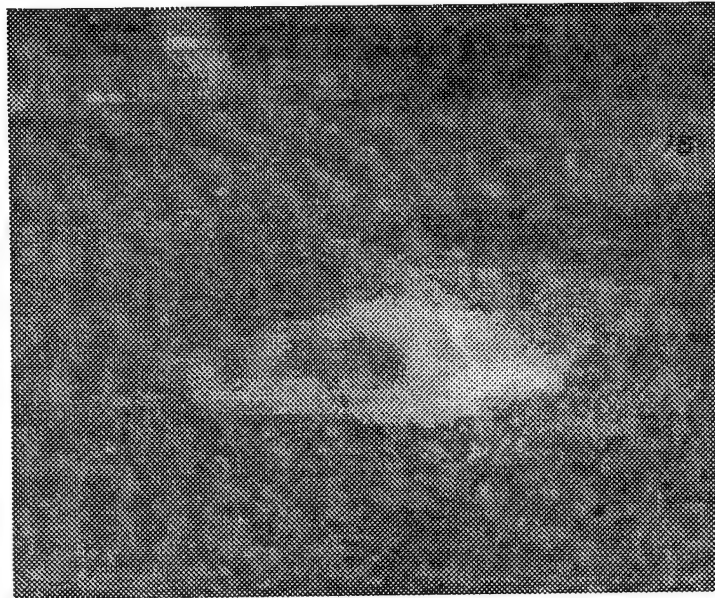
Figure 37. Photograph and thermogram of an area of wet insulation that extends out beyond a patched bare area on the north side of the east penthouse on roof A3, looking a little south of west. Core 15 was taken at the "15."

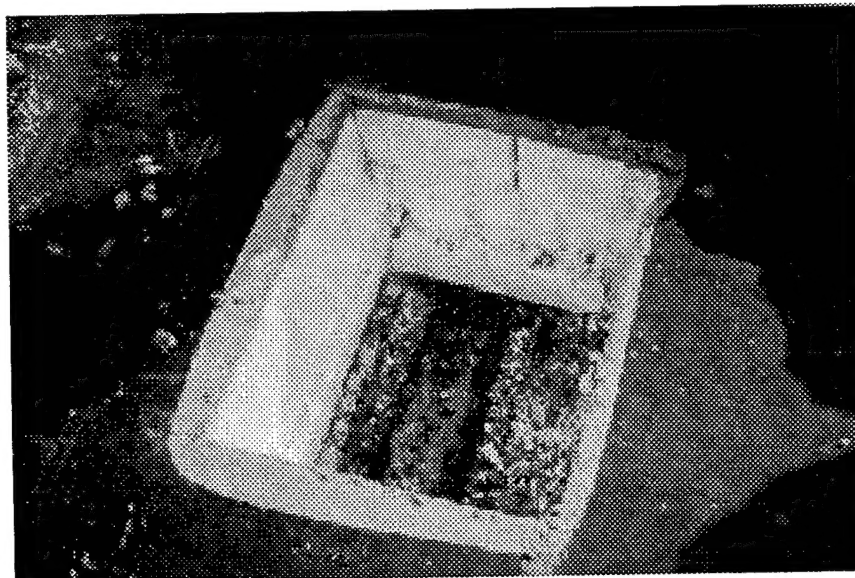
Figure 38. Hole made when taking core 14 and cut I. The bottom layer of perlite on the steel deck was wet and the steel was badly rusted.
